FINAL REPORT FOR STA-2A NDT TESTING

MORTON THIOKOL, INC.

FINAL REPORT ON STA-2A NDT TESTING

25 NOVEMBER 1987

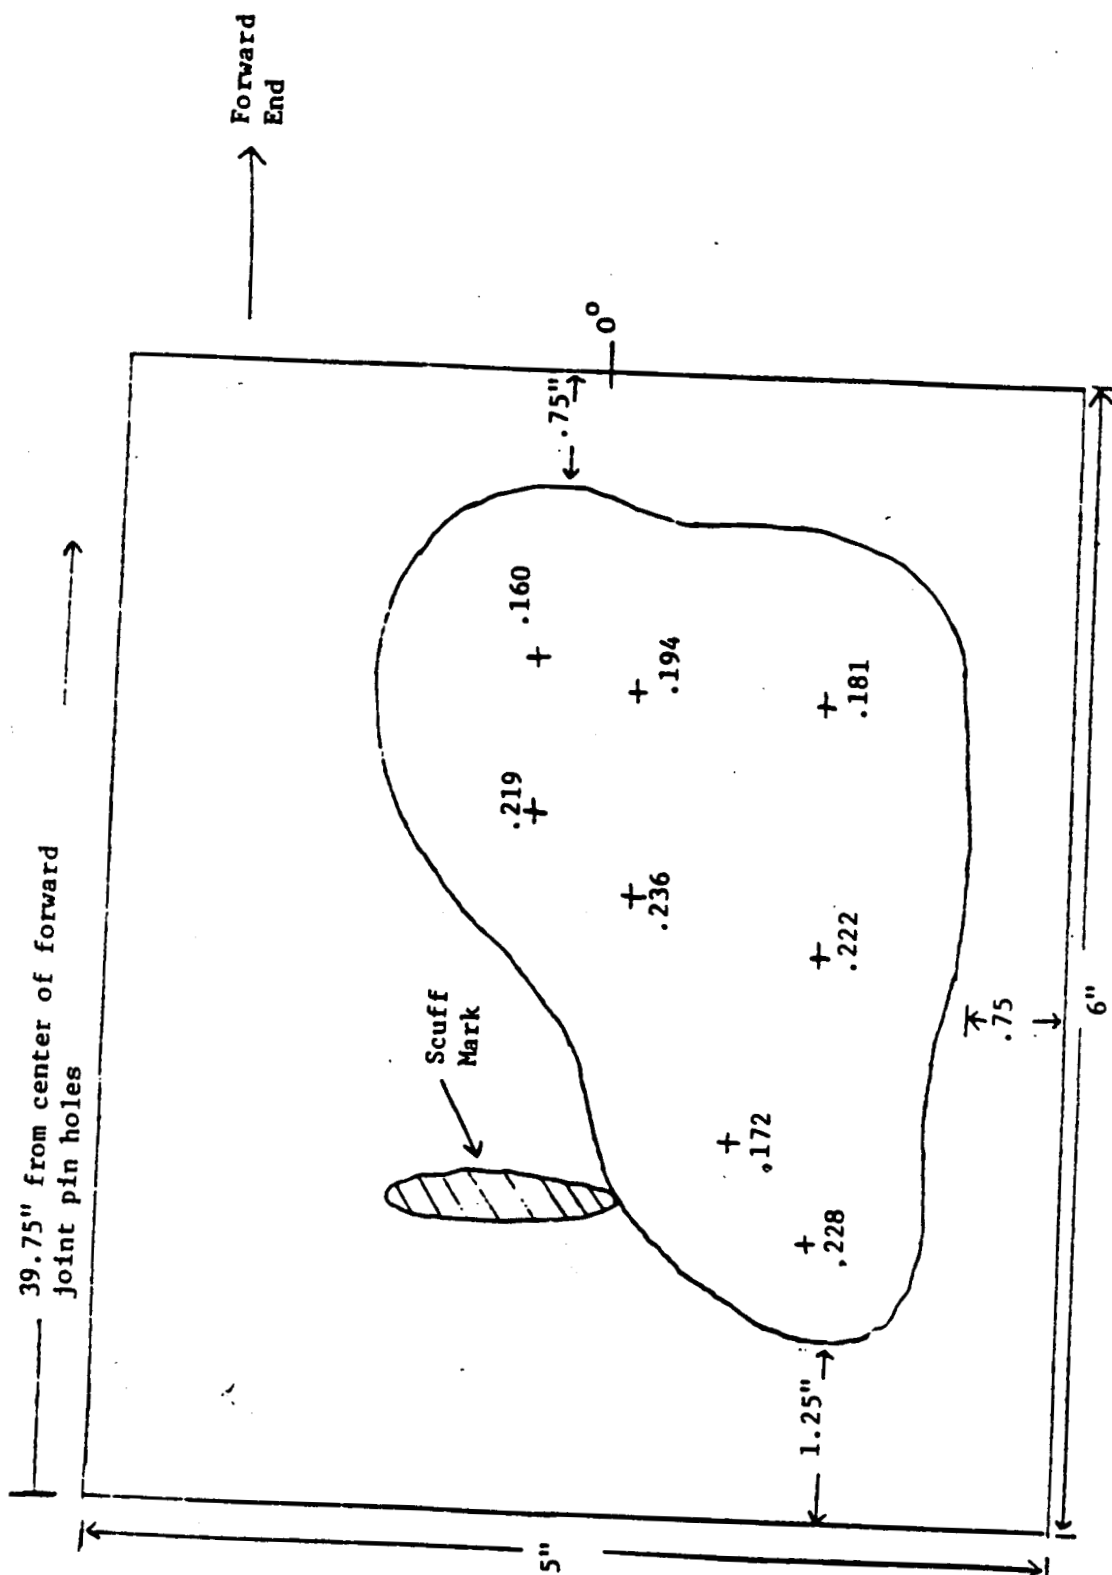
FIGURE 5. DR #4421. ITEM 1

A Pulse Echo inspection was performed on the areas listed in DR #4421 and DR #4473. These areas were hit or scuffed during shipping, installation, or instrumentation of the segments. Figures 5-8 show the results of the inspection. Items 3, 4 and 5 had no indications of subsurface damage. Bob Anderson of Hercules reviewed the recorded scans; Item 1 was not a delamination and was present on the sutra map. Interpretation of the recorded

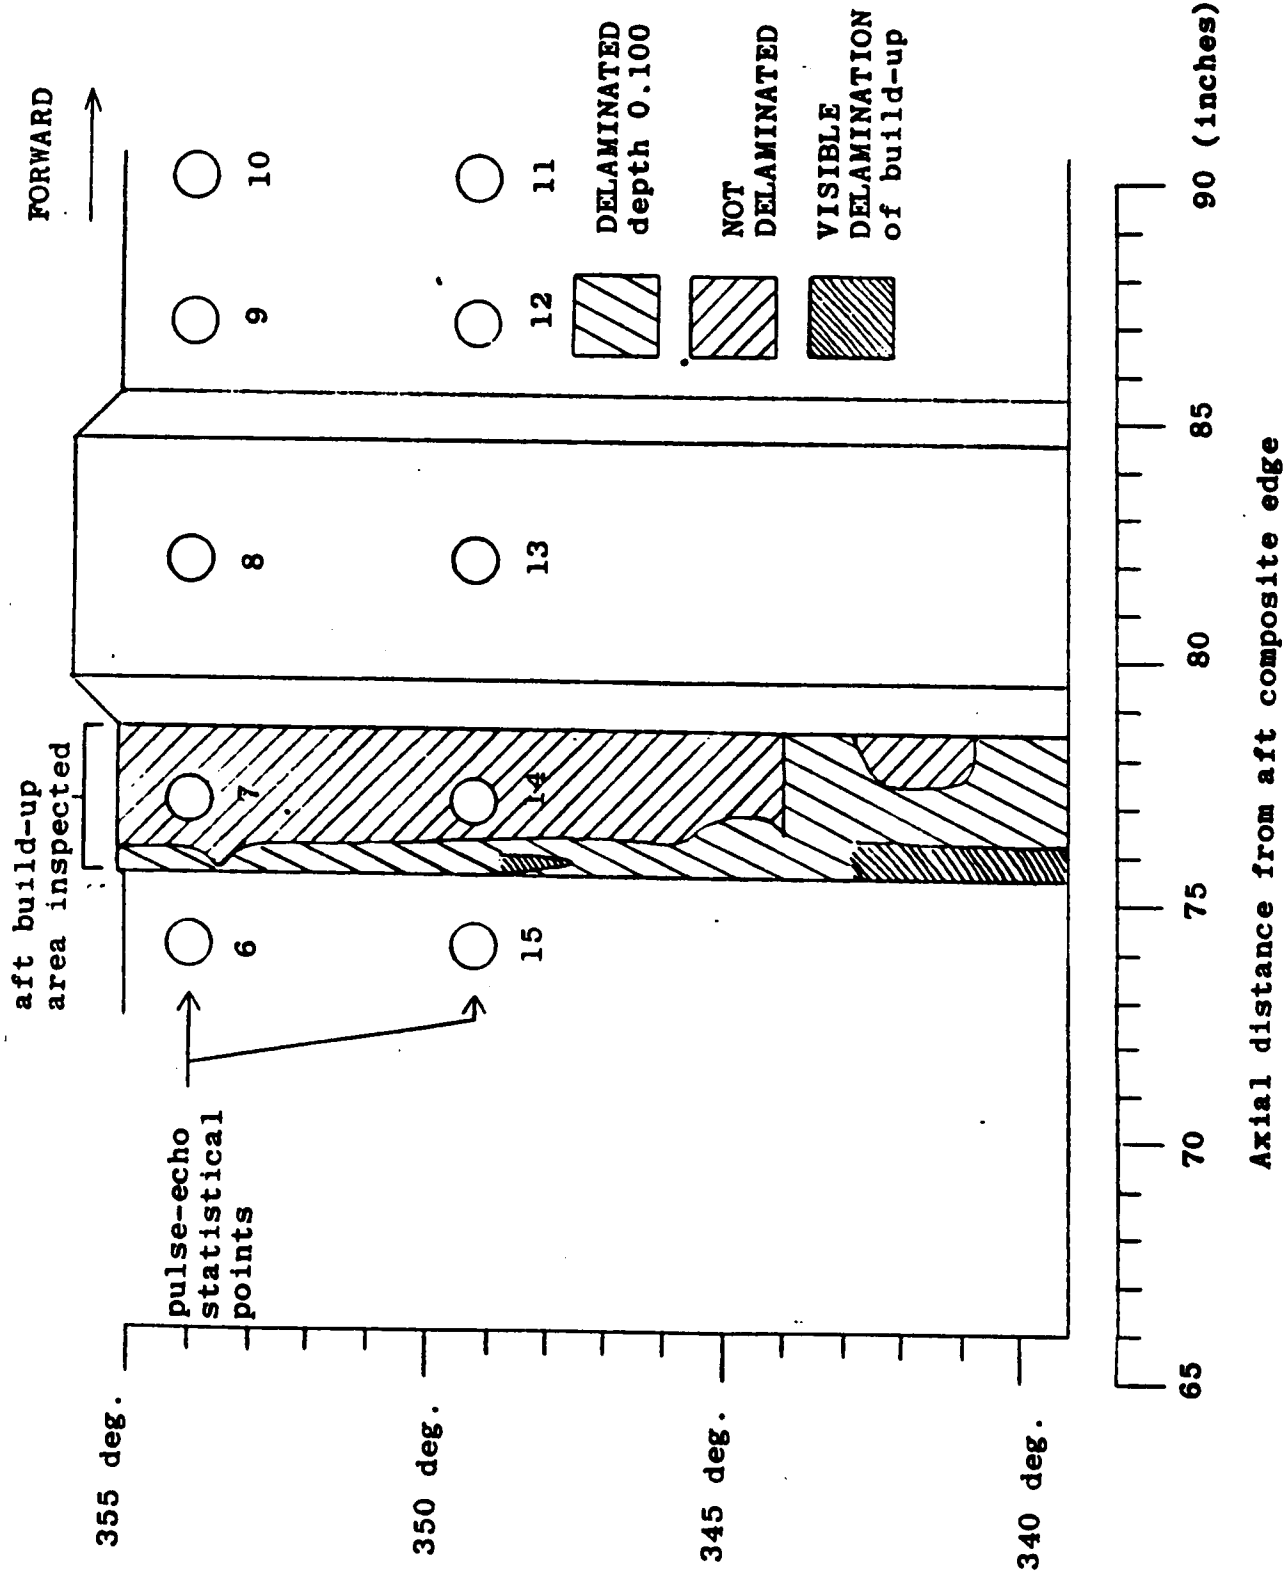
FIGURE 19. STIFFENER RING INSPECTION
AFT SEGMENT FWD RING

A post test Pulse Echo inspection revealed the Stiffener Ribs unbonding. The Forward Rib was approximately 90% unbonded. The Aft Rib was 35% unbonded. The outer composite layer began separating from the layer below it, adjacent to the machined-off Stiffener Rib repaired region. Figures 27-31 show the inspection results in more detail.

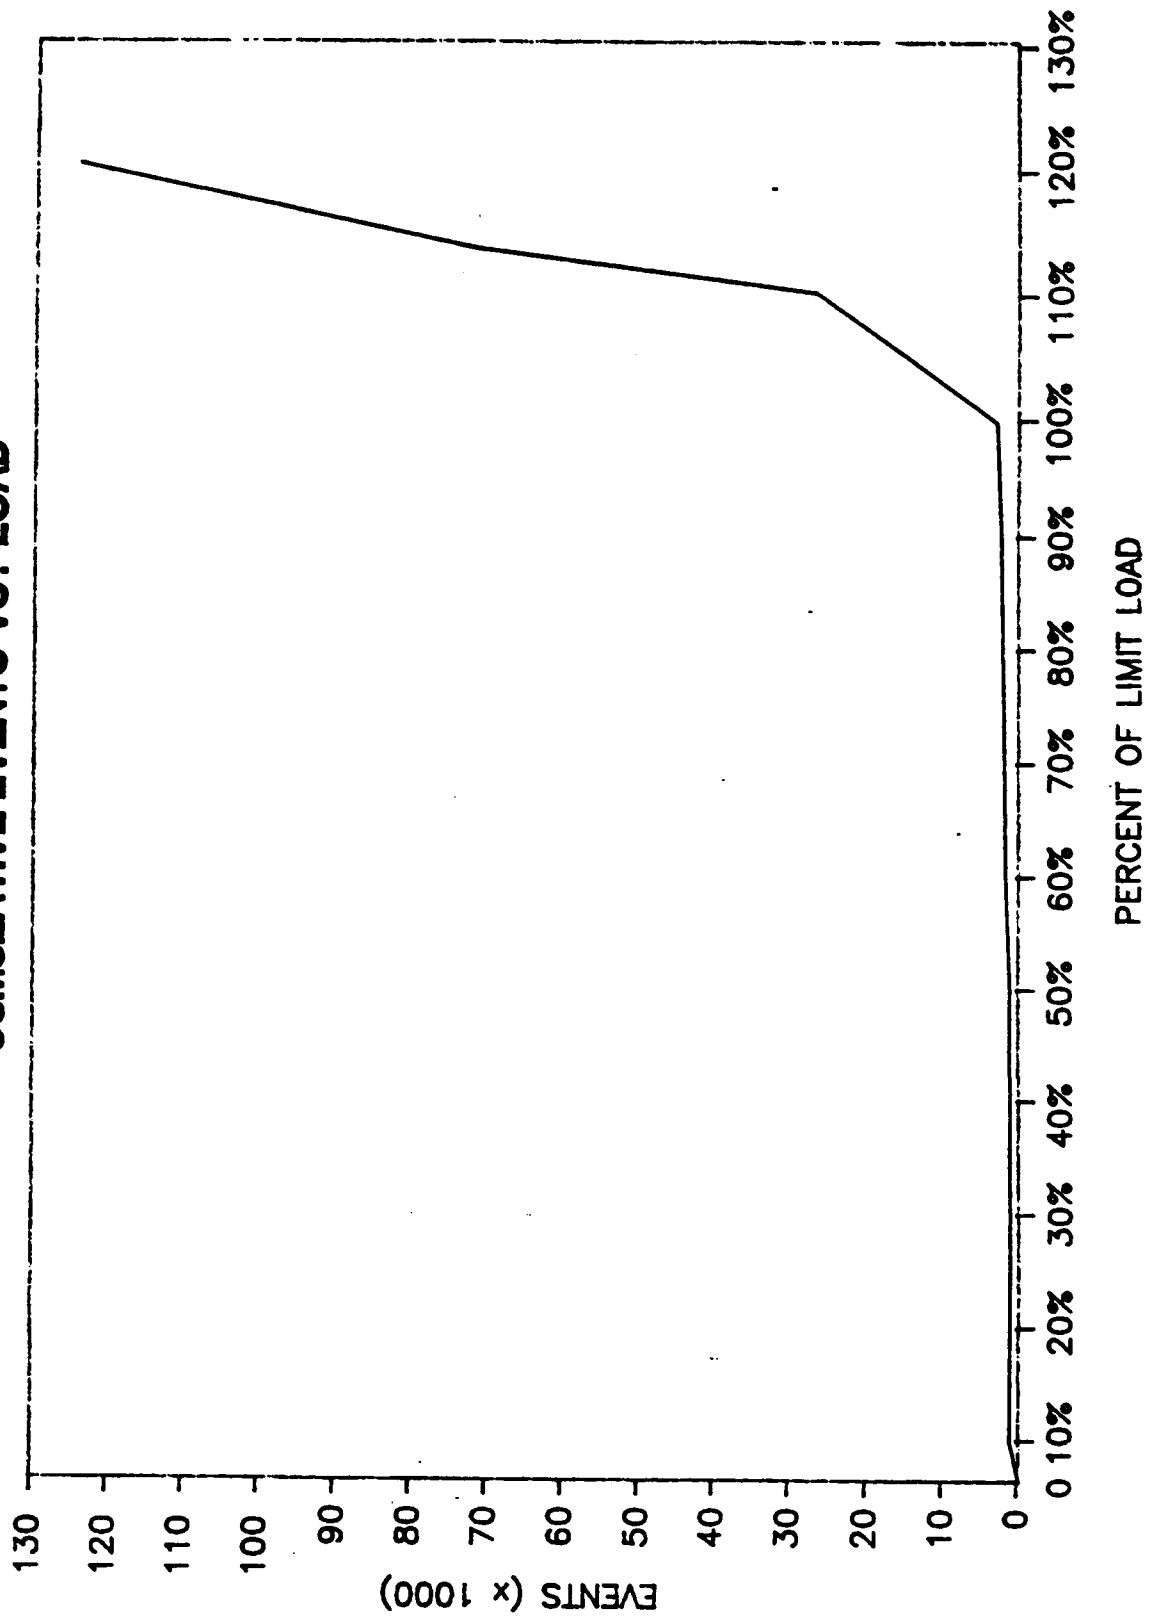
**FIGURE 47. STA-2 PHASE 9C-5TH LOADING
CUMULATIVE EVENTS VS. LOAD**

The fifth load occurred 16 July, 1985. Figure 47, events vs. load, shows that significant defect growth occurred during this test phase. The known delamination area at 160 degrees on the Aft Transition region grew rapidly as the load exceeded 100 percent limit load. The data shows that the defect grew first in the circumferential direction, then in the forward direction, at higher load levels. The AE data indicated that Pulse Echo inspection was necessary. Results of the inspection are

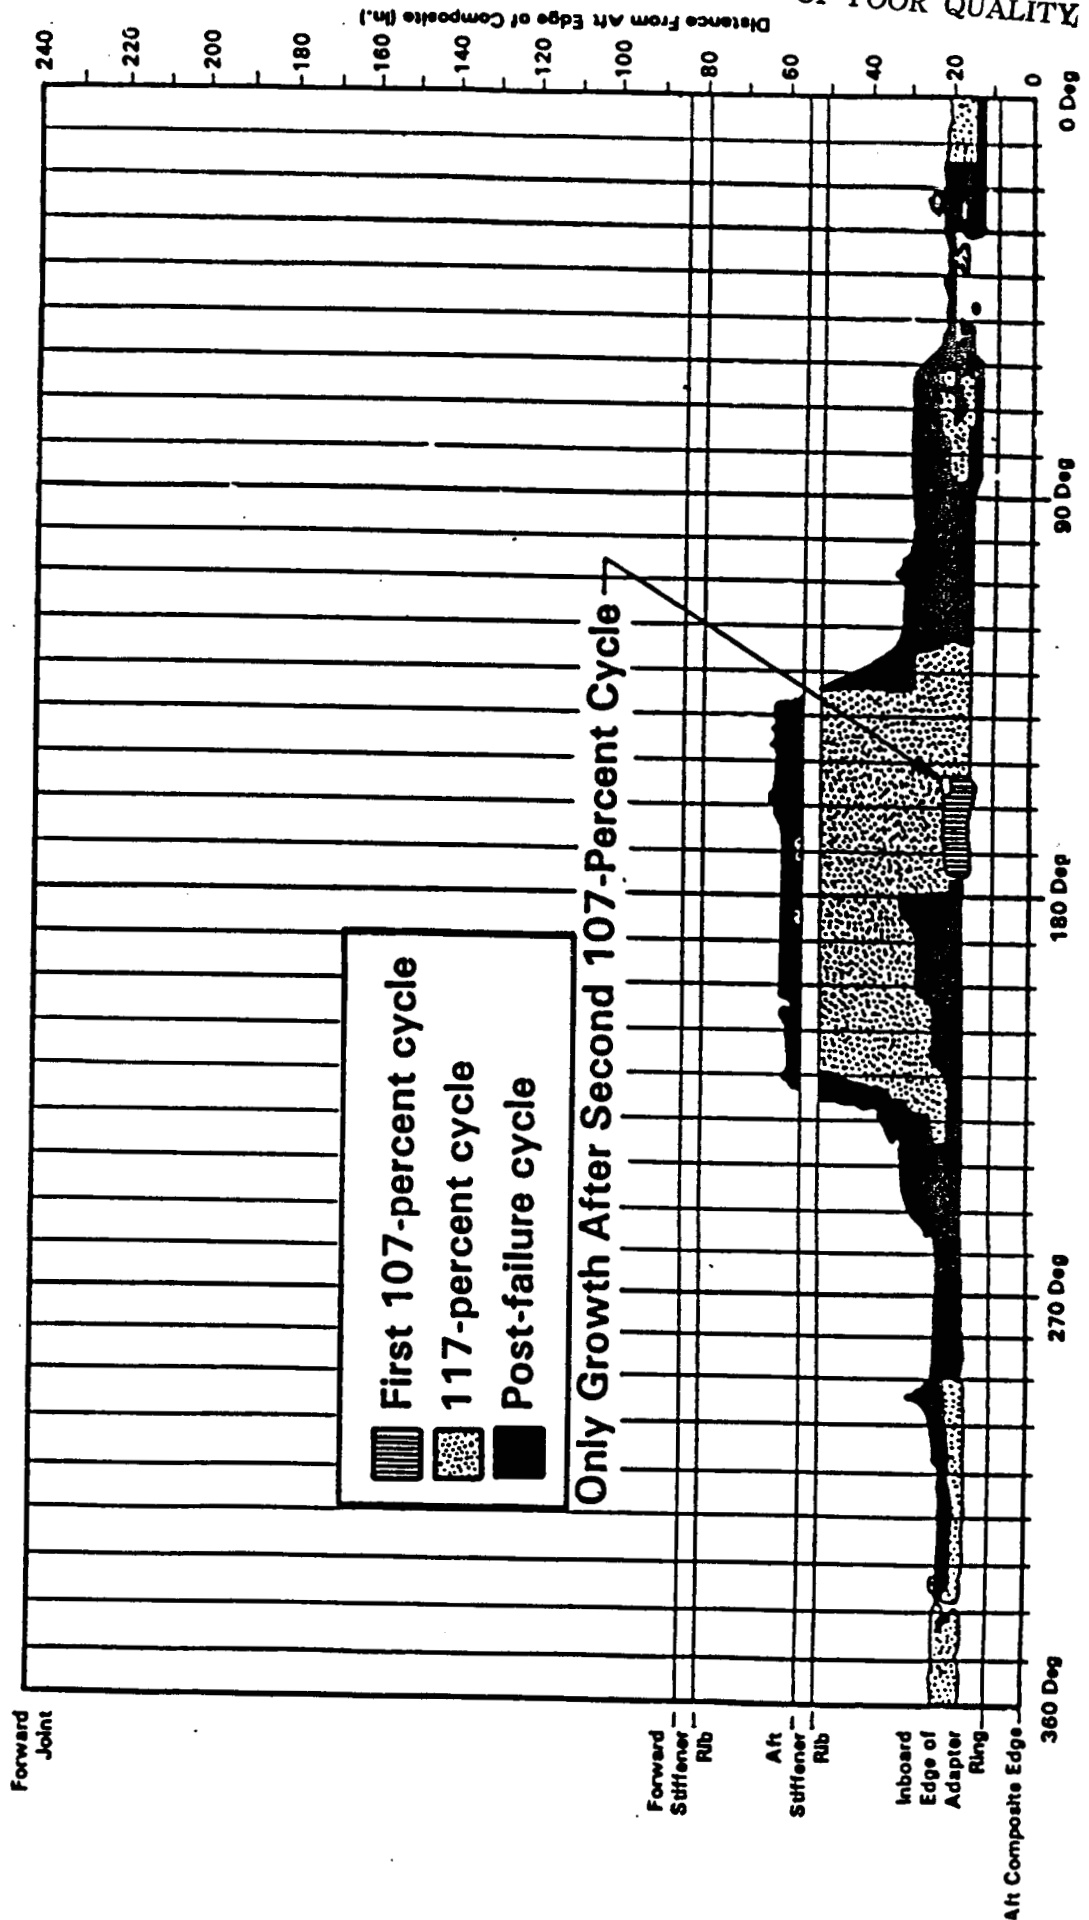
FIGURE 48.

shown in Figure 48. Pulse Echo data confirms the AE data on growth direction and defect locations. The defect growth shown by Pulse Echo agrees closely with the predicated stress analysis model.

STA-2 AFT SEGMENT DELAMINATION GROWTH DURING TESTING

Delamination after 117-percent load test and after failure at 118.4-percent load test

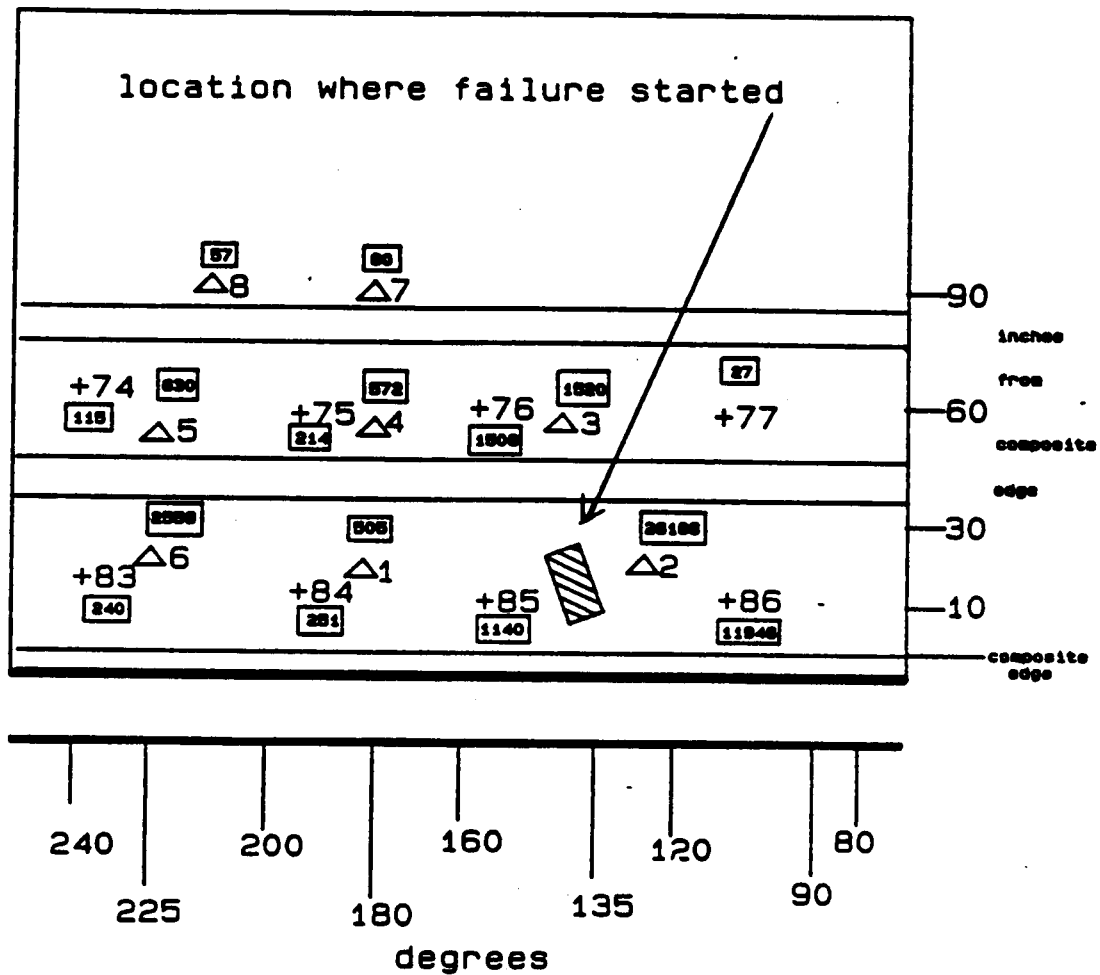
FIGURE 53. FAILURE LOCATION

measurements recorded, indicate the failure occurred in the location shown in Figure 53. Figure 54 shows a topographical map of AE activity for the Aft Segment during failure load.

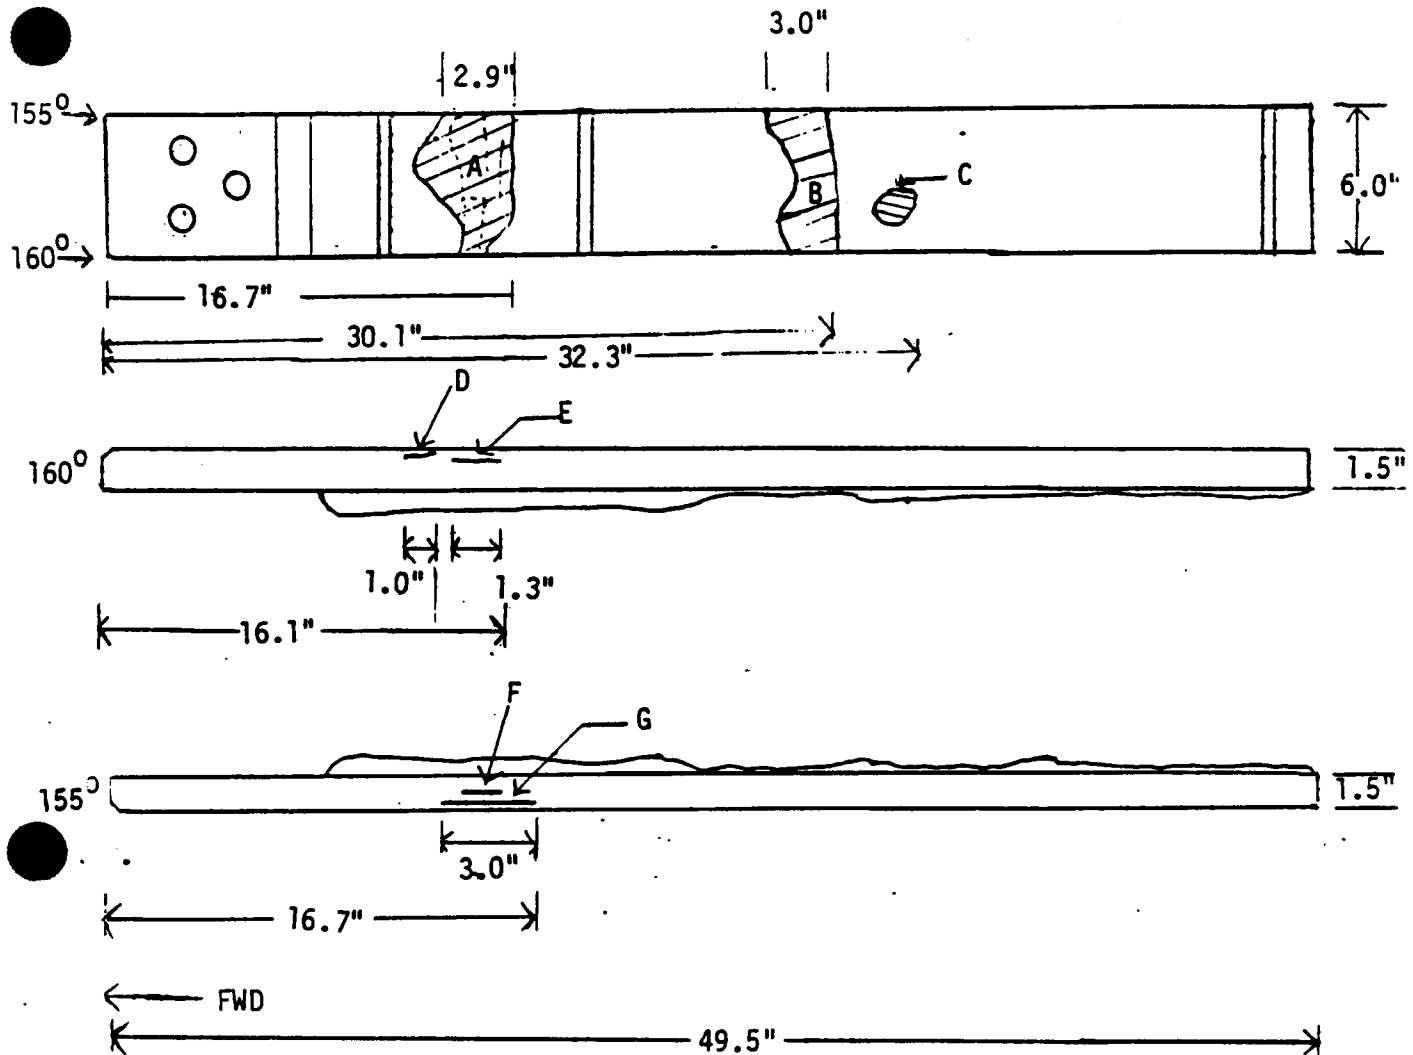
FIGURE 56. SAMPLE #9

- A. UT depth .080" - .120"
Plastilock depth .080" scalar.
- B. UT depth .060" - .075" thick plastilock layer at approximately .080" depth scalar.
- C. UT depth .312"; diameter 1.5".
- D. Visual delam from .085" - .185" cracks across plastilock into ply below. (scalar)
- E. Visual delam from .247" - .290" (sloping ply) scalar.
- F. Visual delam .247" scalar.
- G. Sloppy plastilock (porous) at .100" scalar.

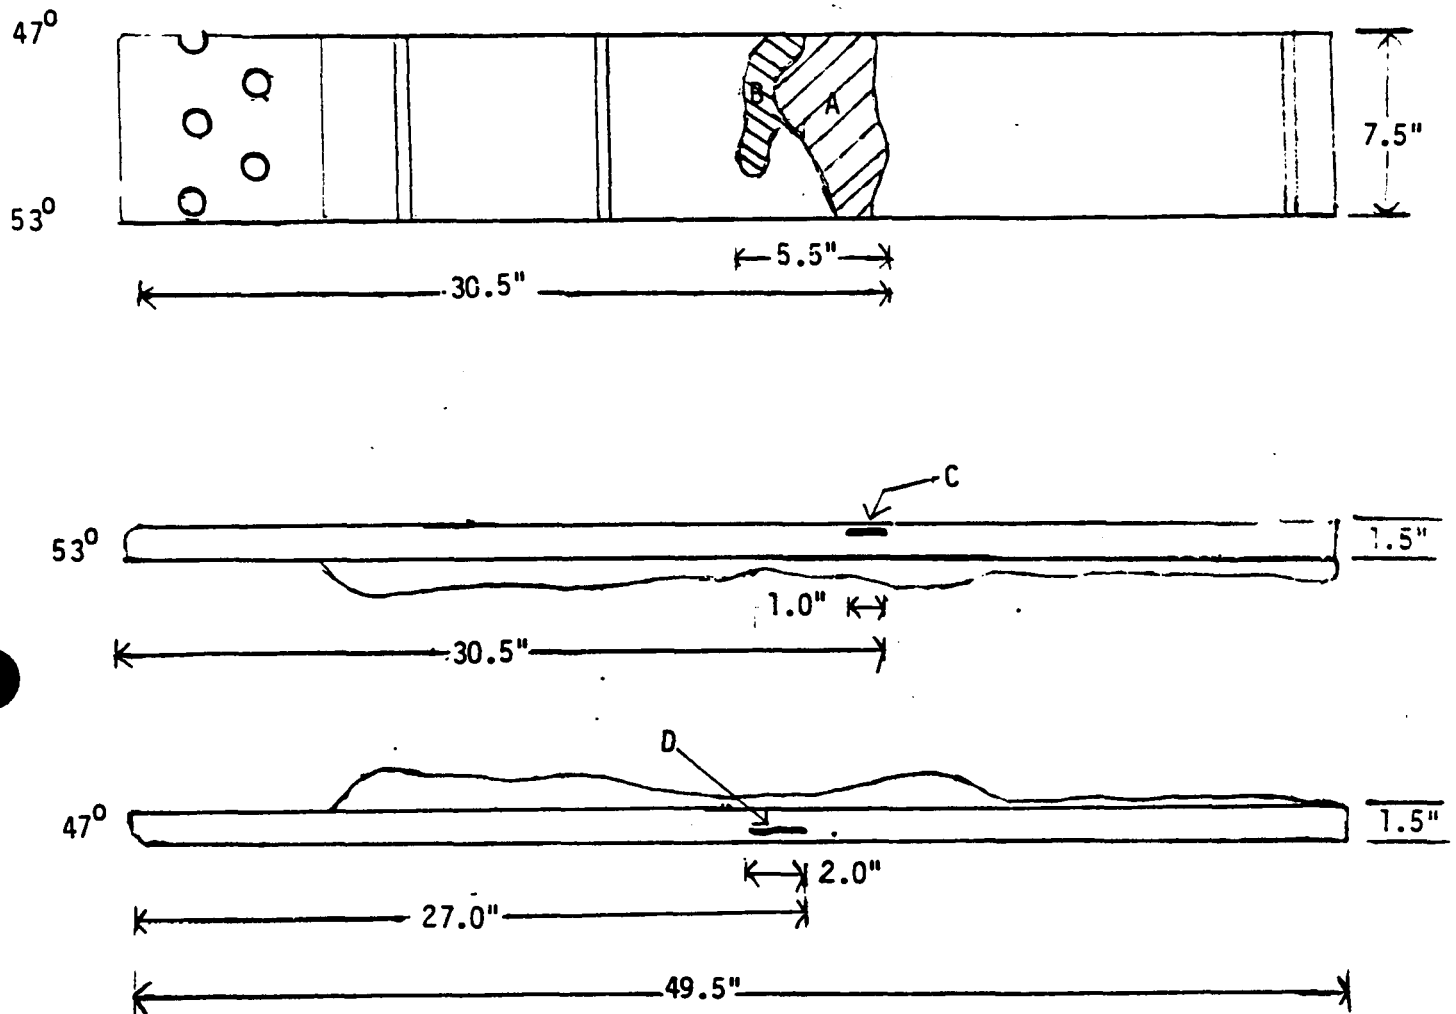
FIGURE 59. SAMPLE #12

- A. UT depth .074"
- B. UT depth .260"
- C. Mechanical depth .076"
- D. Mechanical depth .230" - .245"

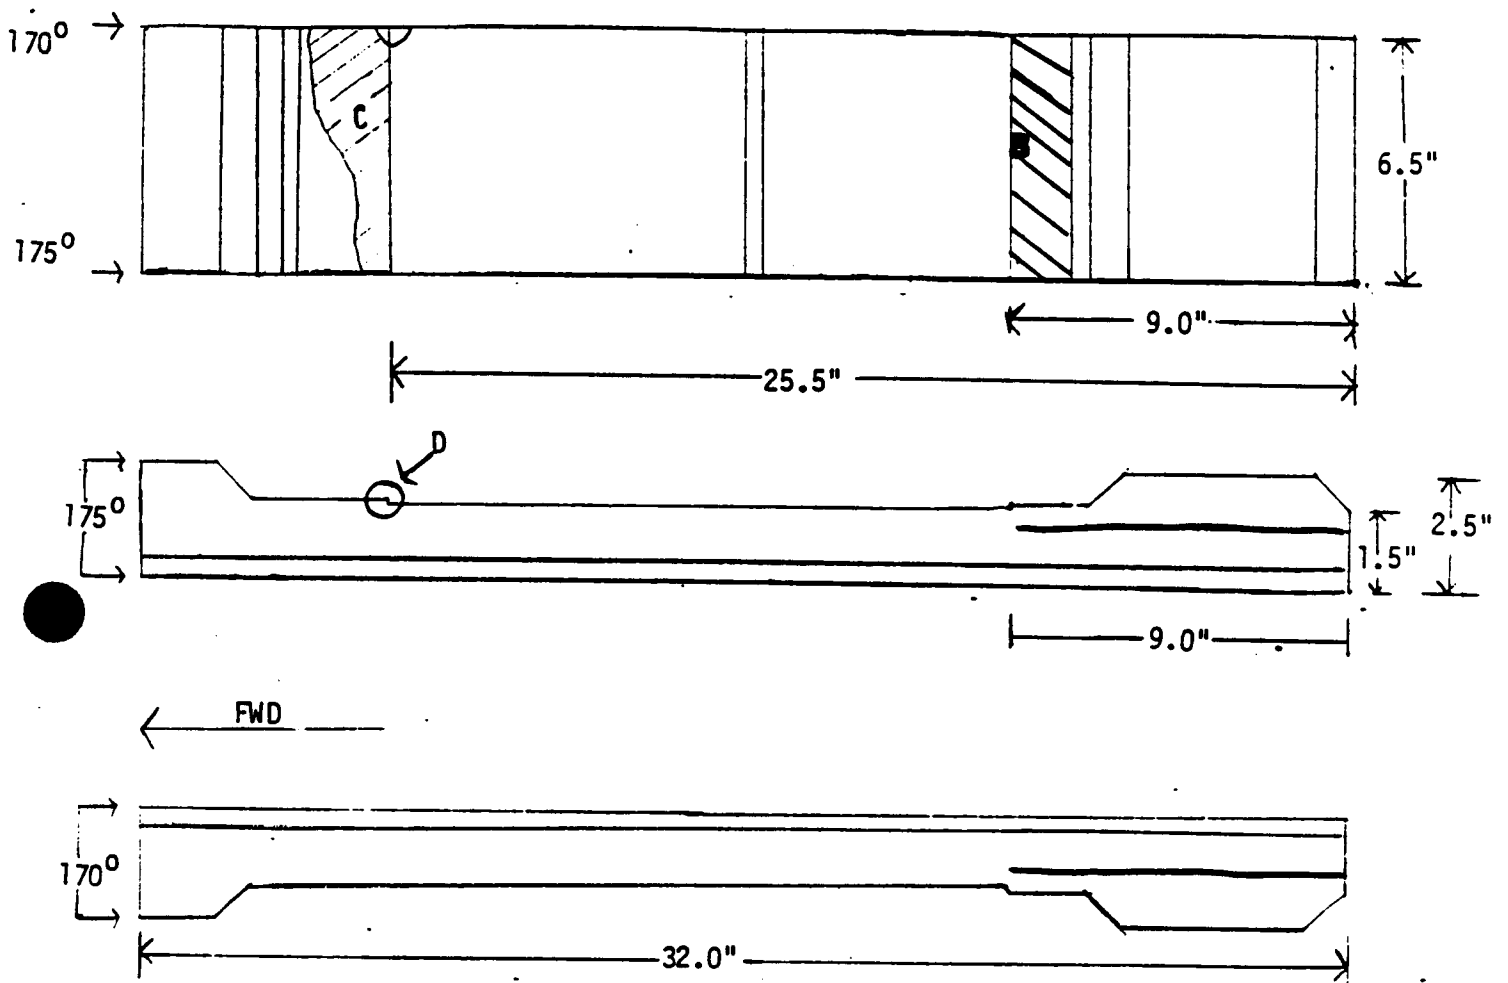
FIGURE 62. SAMPLE #17

Test sample 17 represents the forward edge boundary condition for the failure location. The forward boundary and depth information are critical for stress analysis and modeling. Figure 62 shows the sample dimensions and location of defects. Two defects are seen in this sample; Area A which is the forward boundary of the major delamination and area C which is an unbond of the Stiffener Ring build up region from the case. The Pulse Echo inspection at MSFC shows delamination growth of area A to be approximately 2 inches forward of the Stiffener Rib. Figure 63 shows a picture of this delamination. The Pulse Echo depth measurements of these flaws at MSFC gave an indication of 1.300 inches at point A and 0.530 to 0.547 inches at point B from the OD. The measured mechanical depths from the OD are 1.480 inches for point A and 0.600 inch for point B. The full wave Pulse Echo signal for location A and B are shown in Figures 64-65.

- A. Visible delam: depth mechanical 1.480" (O.D.) UT depth 1.300"
- B. UT depth .530" - .547".
- C. High UT signal over 100% S.H. in center at .065" depth.

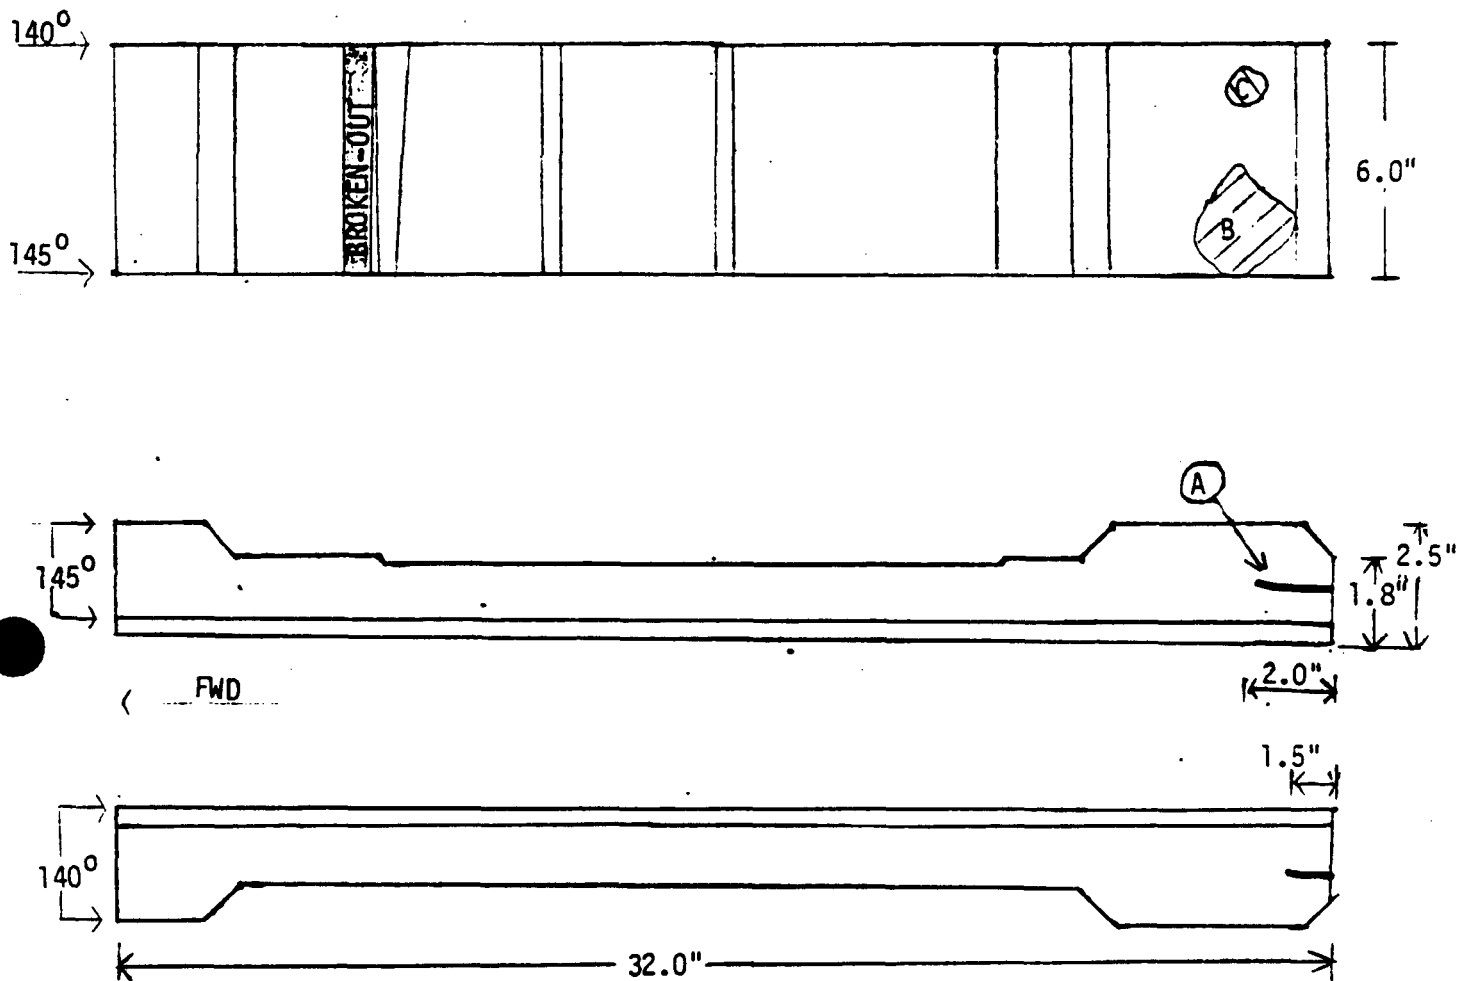
FIGURE 68. SAMPLE #18

- A. Scalar depth 1.515" from OD surface of Stiffener Rib.
Approx. scalar depth from OD cylinder .450". (ie - less Stiffener Rib).
- B. UT depth 1.715" (75% S/H).
- C. Small delam depth UT 1.734"

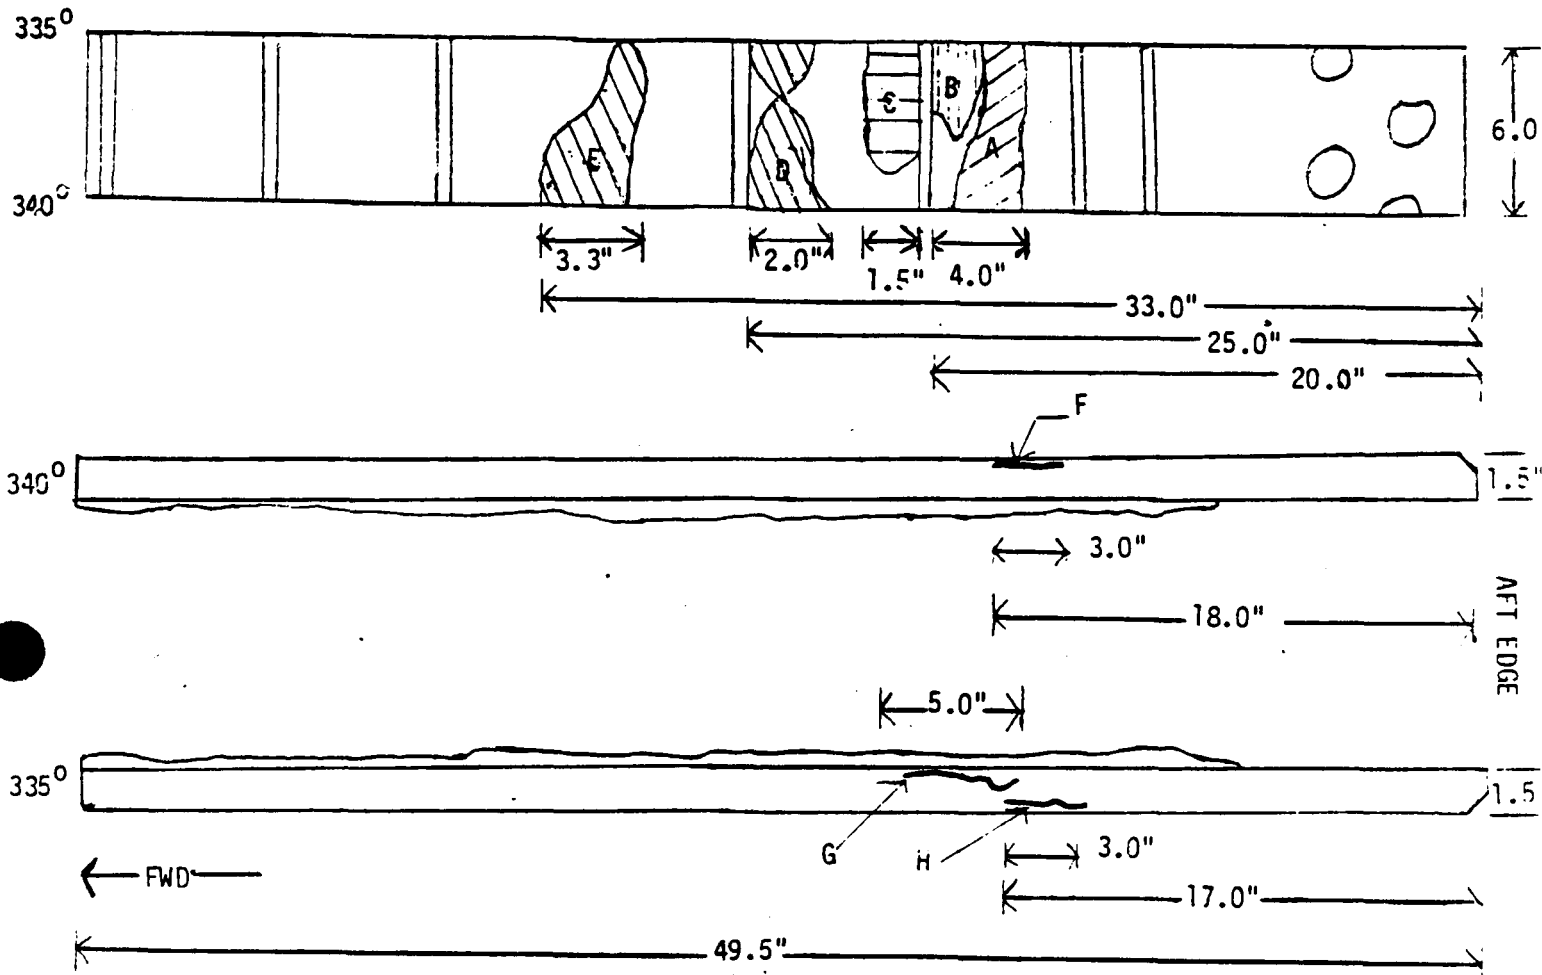
FIGURE 70. SAMPLE #19

A. UT depths .100" - .110" (porous plastilock)

C. UT depths .100" - .110" (porous plastilock)

H. Cross-ply cracking from .095" at 14 inches (plastilock) to .340" at 17 inches (scalar).
